# SHOP TALK

VOLUME 6 NO. 1

# THE HAIRLINE PROBLEM

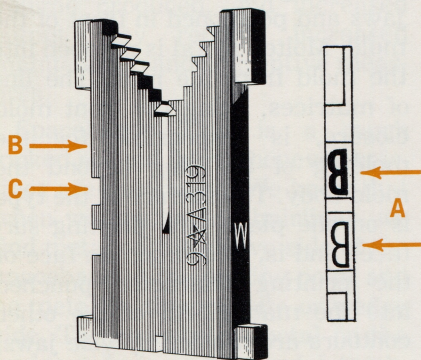
- A. Punched character of matrix (printing plane)
- B. Edge of matrix body (mold height plane)
- C. Side wall of punched character (between printing plane and mold height plane)

Examine a matrix and note how slight the difference is between the side wall and printing plane. The side wall is not always a straight line as in the above figure, but in the case of the letter "O" has a depression in the center. Other characters show the depression in various locations along the side wall area.

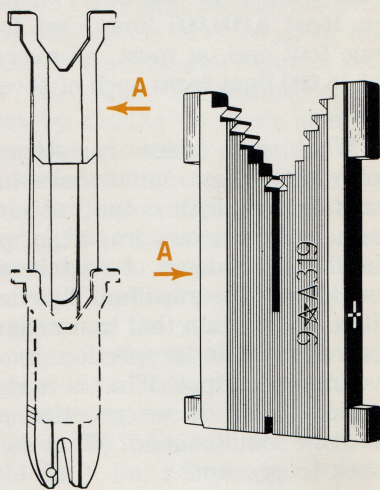
- A. Edge of spaceband and quad matrix (mold height plane)

In the spacebands and quads we have but one plane. But, and a very big but, we find that spacebands and quads appear in the contour of the cast slugs showing more than their edges. The sides of spacebands and quads are also

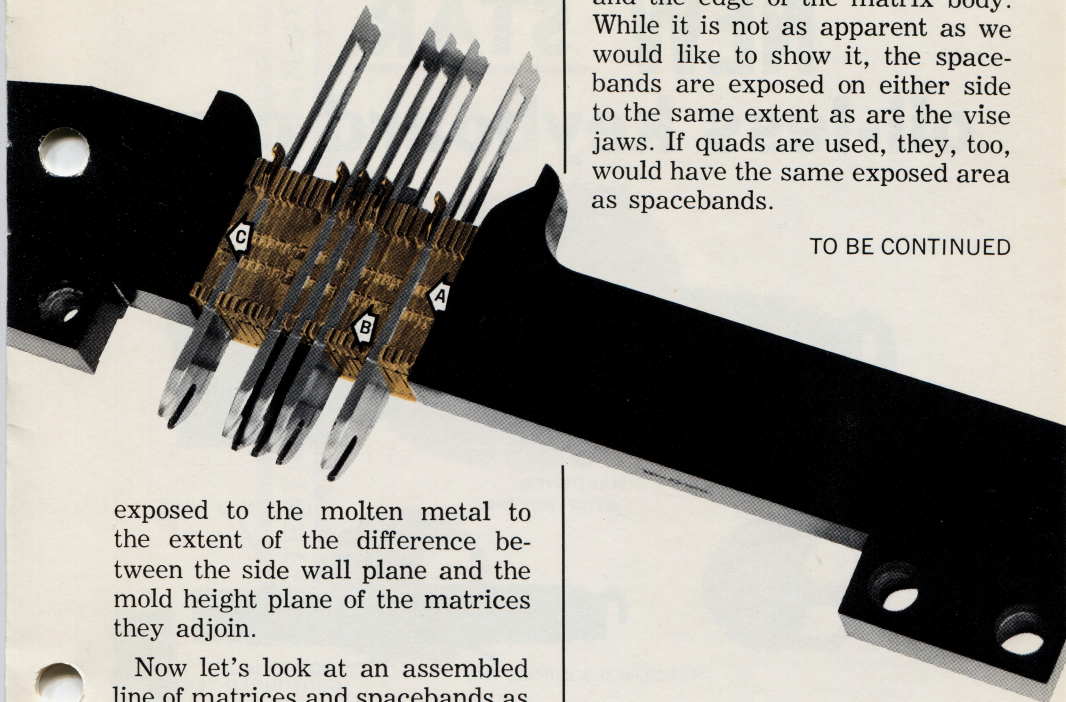
and the edge of the matrix body. While it is not as apparent as we would like to show it, the spacebands are exposed on either side to the same extent as are the vise jaws. If quads are used, they, too, would have the same exposed area as spacebands.

exposed to the molten metal to the extent of the difference between the side wall plane and the mold height plane of the matrices they adjoin.

Now let's look at an assembled line of matrices and spacebands as it would be positioned before the mold during the actual casting of a slug.

- A. Punched character of matrix (printing plane)
- B. Edge of matrix body (mold height plane)
- C. Side wall of punched character

Note how the various planes mentioned before appear during the cast.

Note particularly point C. The vise jaws which squeeze the line of matrices and complete the closure of the front of the mold are flush with the mold body B. It will be readily seen that the faces of the vise jaws that contact the matrices are exposed to the molten metal to the extent of the difference between the side wall plane

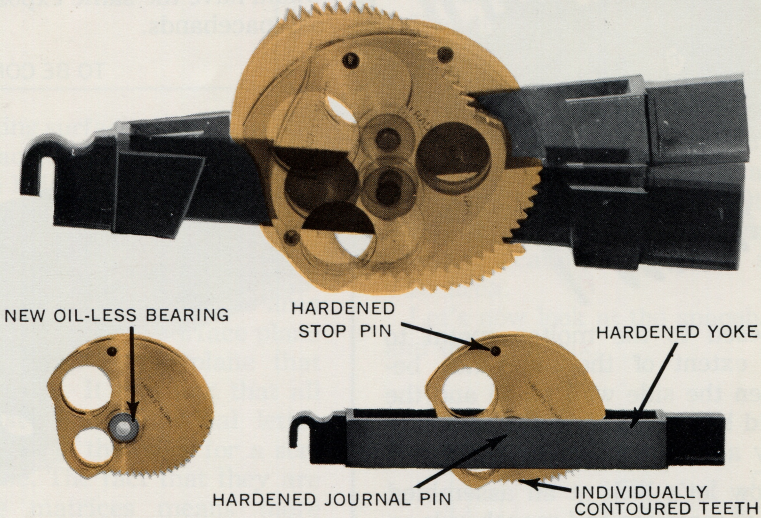
# NEW STAR oil-less keyboard cams

The new Star oil-less keyboard cams never require lubrication. They are equipped with engineered plastic bearings, which revolve on hardened journal pins. These special bushings practically eliminate friction and reduce maintenance to near zero.

Other advantages of the improved Star cam include individually contoured teeth which grip the rubber roll to give fast, positive lift to the key rod. Both the cam stop pin and yoke are hardened, providing long trouble-free life.
